GROUND INVESTIGATION REPORT

**SMALL PLOT OF LAND OFF ESKDALE
AVENUE, CARR MILL, ST. HELENS**

Date: May 2008

Job Ref: 6561

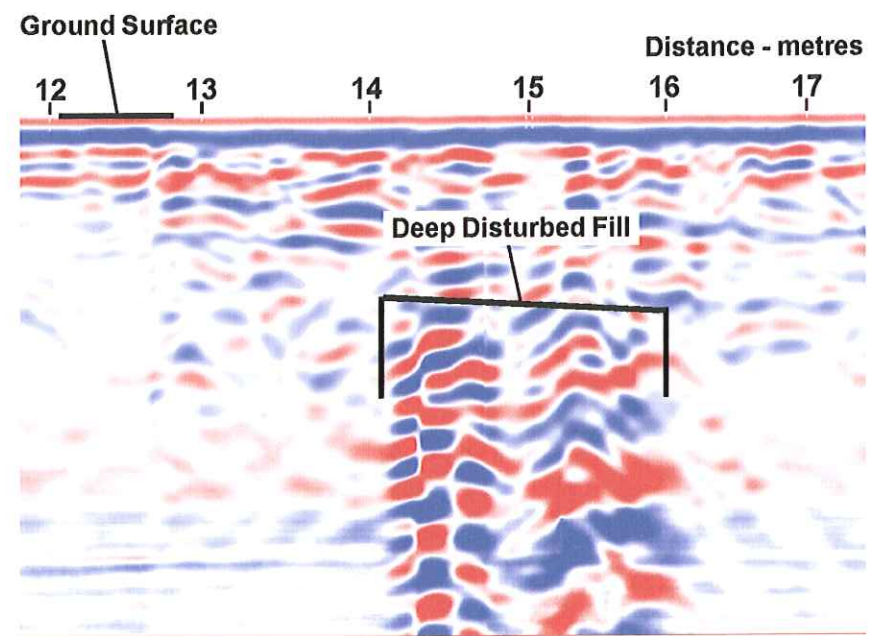
(i) Transverse Profile

Fig. 3 Example GPR Profiles, Eskdale Avenue, St Helens

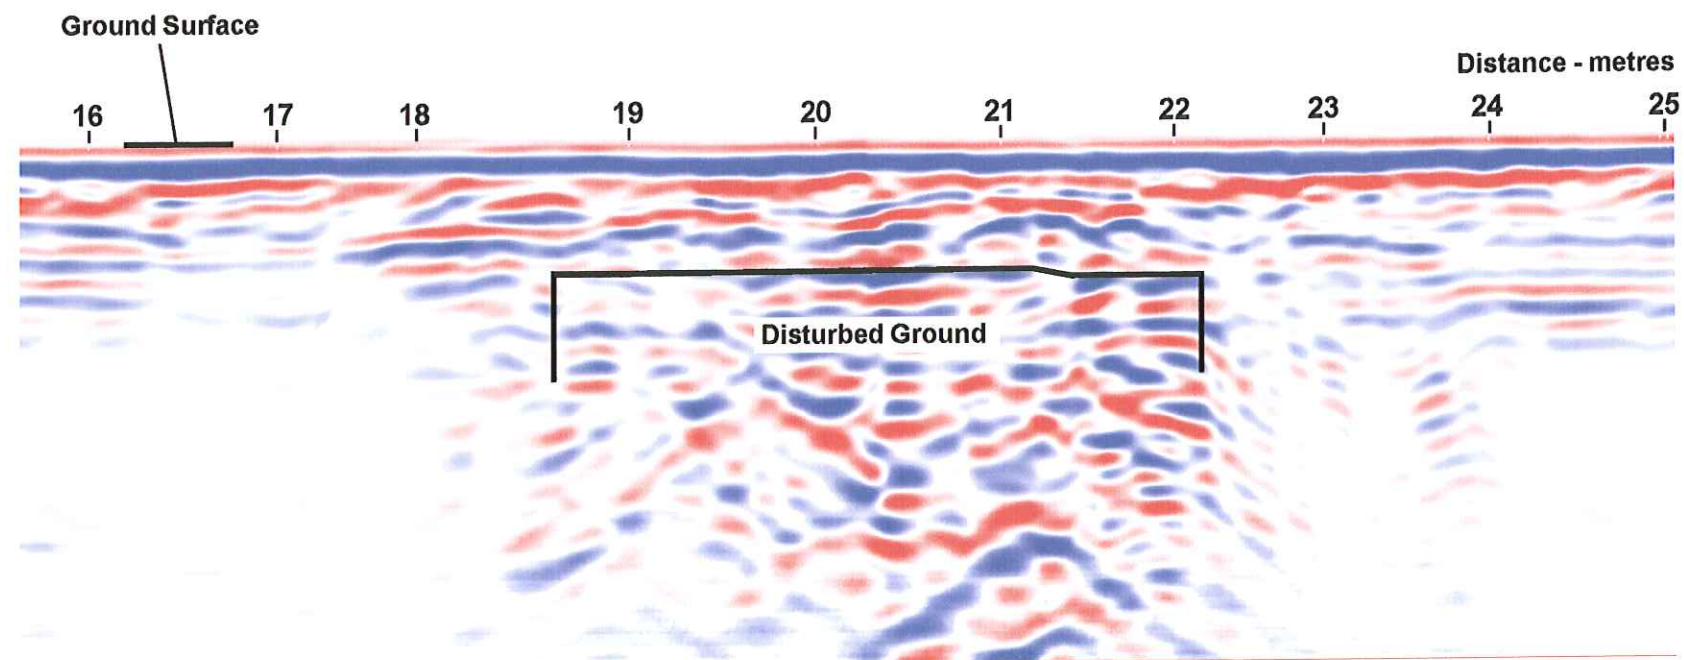
(iii) Longitudinal Profile

This reflection category is characterised by moderate-high amplitude, irregular heterogeneous reflections showing broken layering or a chaotic internal structure. Due to the chaotic reflection characteristics associated with this type of ground, it is often difficult to identify individual features within zones of disturbed ground. It is possible that some targets present within these areas may not have been detected by the GPR survey. Figs. 3ii and 3iii present examples of the disturbed ground reflection category.

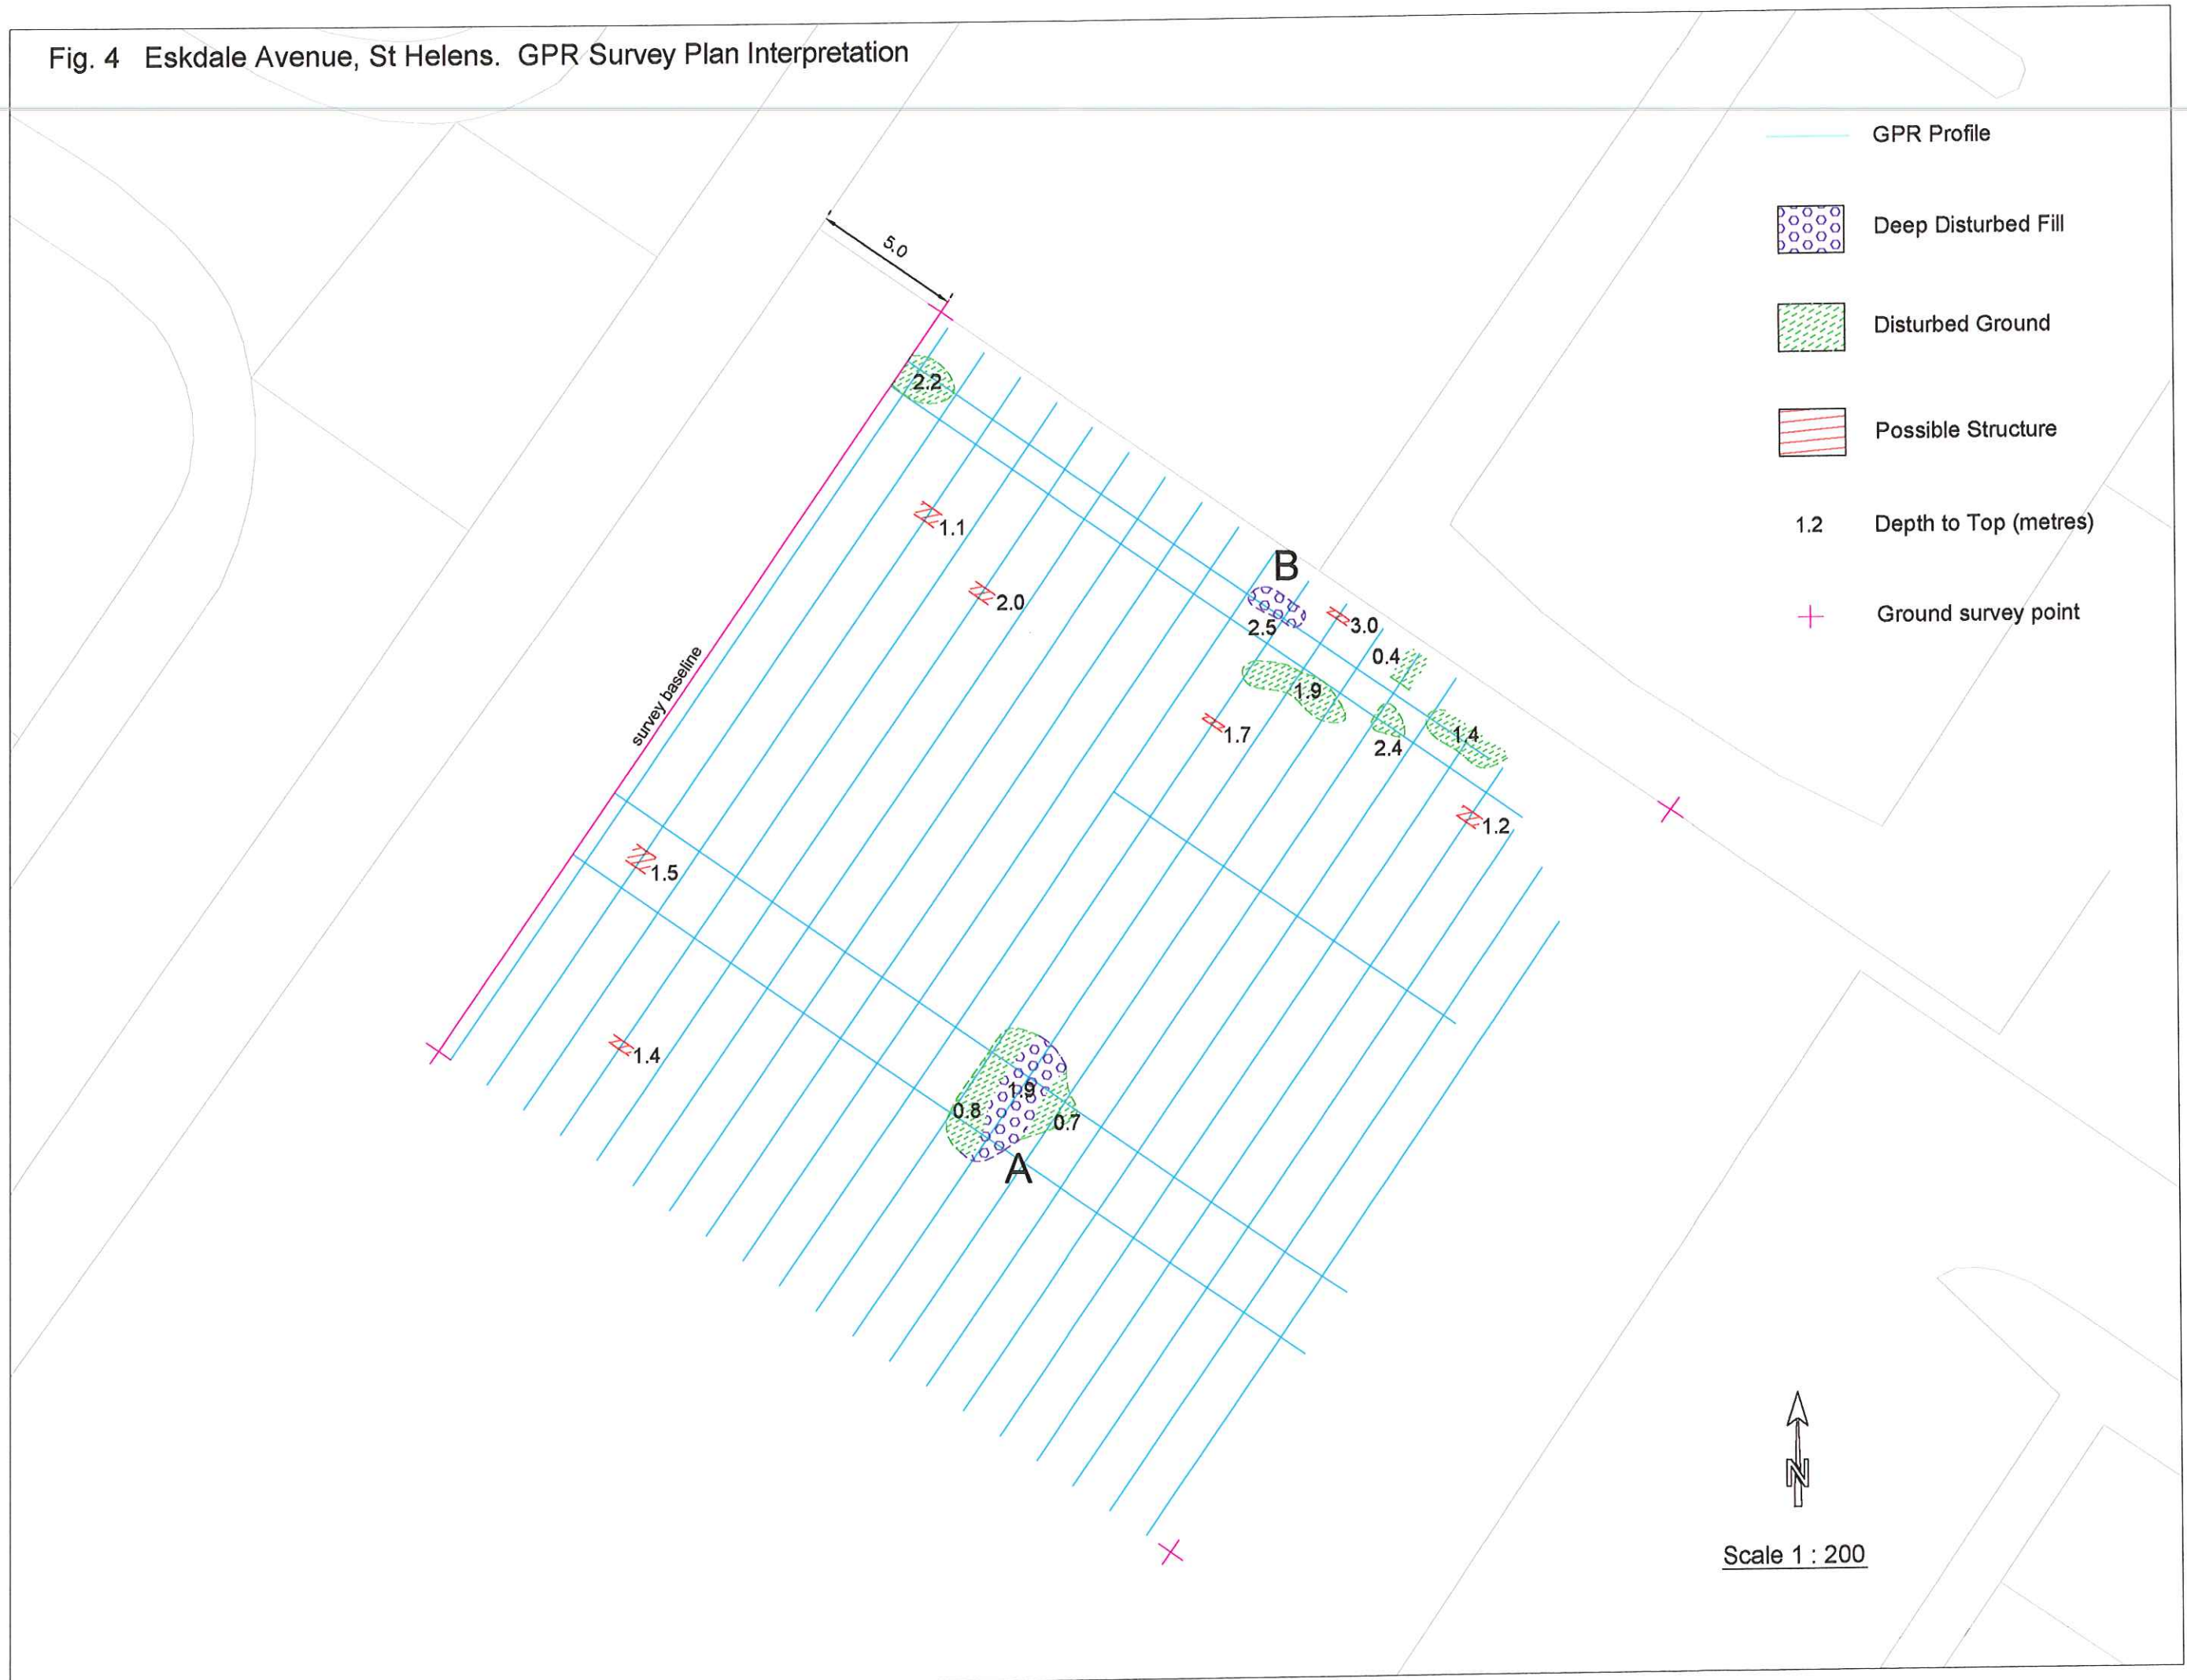
Fig. 4 Eskdale Avenue, St Helens. GPR Survey Plan Interpretation

The depths in metres to the tops of the GPR targets are presented on the plan interpretation. It is estimated that the cover depths to the tops of the targets are accurate to roughly $\pm 30\%$.

The most significant target detected is the large composite zone of disturbed ground with a central core of deep disturbed fill (target A), located in the middle of the southern half of the site. This feature is almost 5 metres long and broadly coincides with a depression visible on the ground surface. Possible causes of target A would include a collapsing mineshaft, a crownhole, or deep former excavation that was poorly compacted when backfilled.

A second smaller area of deep disturbed fill (target B) is located close to the wall forming the north-eastern site boundary. This zone of deep disturbed fill is roughly 2 metres long. The nature of this anomaly is uncertain. There are three nearby areas of disturbed ground to the south-east of target B. Disturbed ground is caused by factors such as changes in ground composition, backfilled excavations or possibly areas of slight ground settlement. One other area of disturbed ground is located by the northern corner of the site, near the grid origin.

The small buried structures scattered around the site are probably indicative of features such as concrete or masonry blocks or larger pieces of scrap metal.

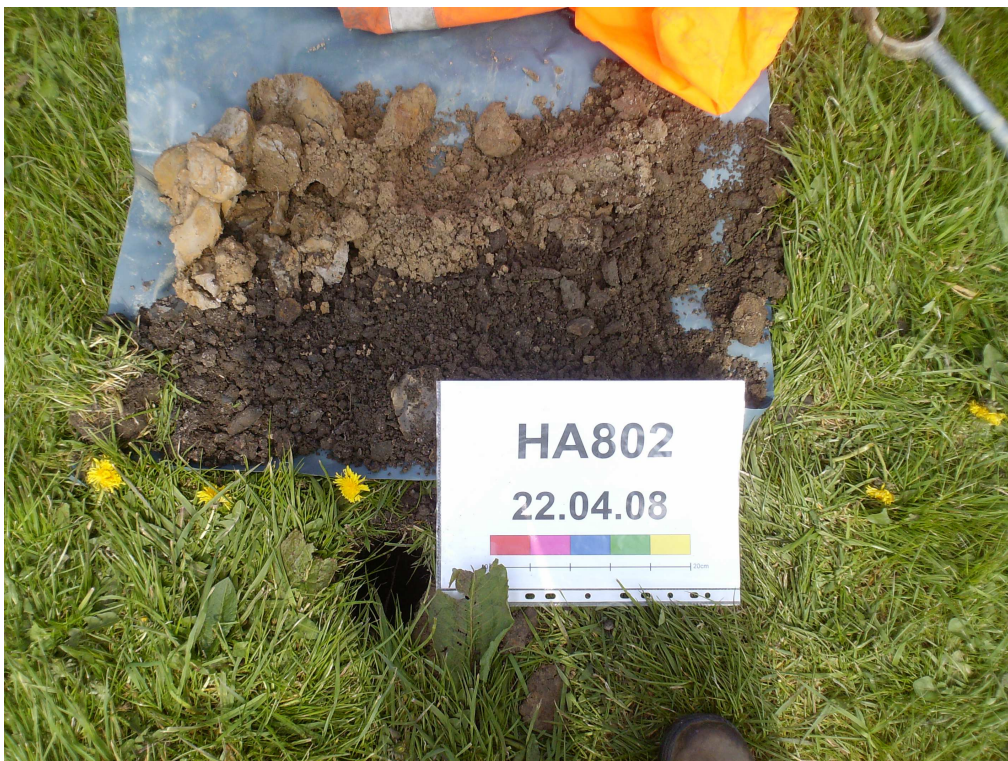
When compared to residential with plant uptake SGVs and GACs, two soil samples were found to contain elevated arsenic (29mg/kg, HA802 and 27mg/kg, HA806). One sample was found to contain elevated benzo(a)pyrene (BaP) (1.9mg/kg, HA806), copper (120mg/kg, HA802) and zinc (400mg/kg, HA806).
